Cantón Quiacquix, Departament of Totonicapán. Guatemala.

Water Project

September 2022

The present document summarizes information gathered during a field visit made August 8th 2022 at the request of the community to express their need for support with a potable water project.

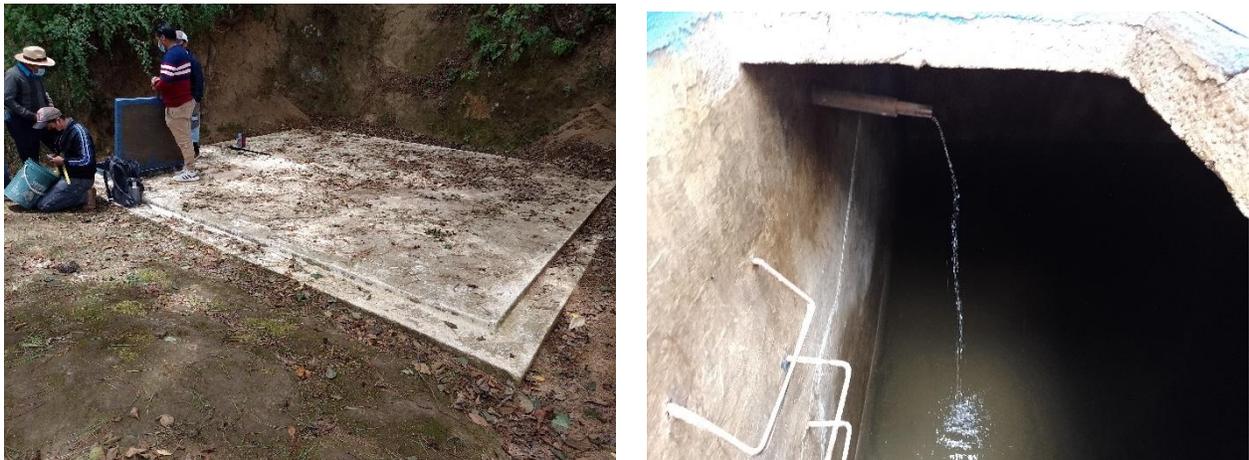
Flowrate was measured during our visit on the inlet pipe of the distribution tank; it was of 0.014 liters per second. This flowrate makes the system almost useless to supply the population or a fraction of it. According to the Guatemalan standards where minimum demand *per cápita* is of 60 liters/person/day, the system would be able to provide for 20 persons each day.

The 3 Parajes Water Committee expressed that they close service for days, to wait for the distribution tank to fill, and then distribute to some families at least a small quantity of water.

Figure : Distribution tank of 3 Parajes System.

Water samples were taken from the inlet pipe of the tank. Results are shown in appendix A. The physicochemical parameters that were tested are appropriate according to the Guatemalan standards. What is of concern, is the significant amount of total coliform presence showing in the bacteriological test, which shows the water is not being treated.

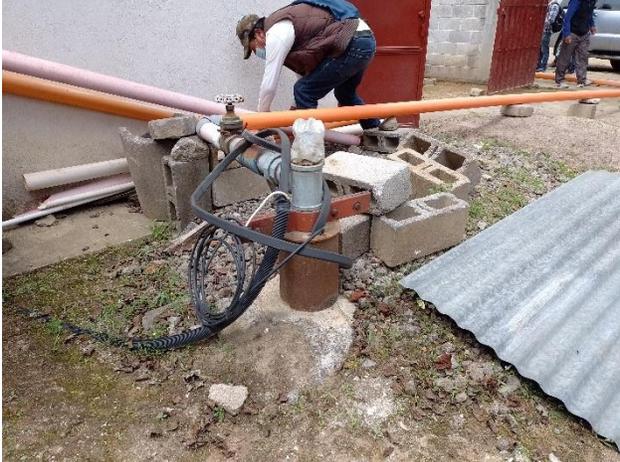
Wellhead

The community provided copy of technical specifications from a design with date 2005. It mentions the well to be of about 600 feet deep and 12" in diameter. Pipe casing of 8" in diameter, and that it produced 90 GPM in the pump test.

As the well was drilled 13 years ago, it is recommended to schedule cleaning it before the system is put to work.

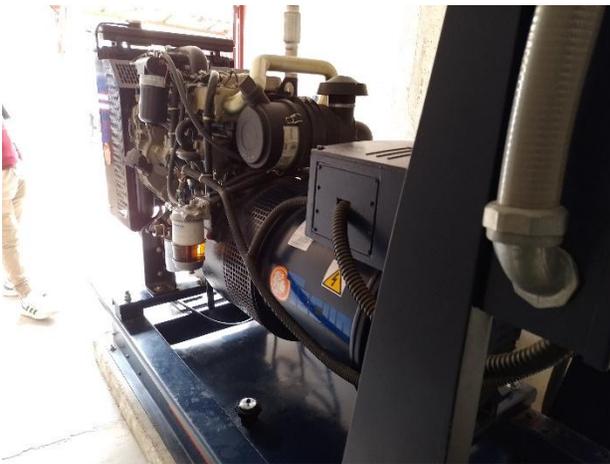
Diesel power equipment

We verified on field that the community has a diesel fed power generator for the pumping equipment that seems well maintained. The equipment is turned on for some minutes every two weeks to prevent damage. However, we suggest to change the diesel generator to electrical grid power, as electricity would cost less. This change can contribute to the sustainability of the project, as observed in other projects in Guatemala.

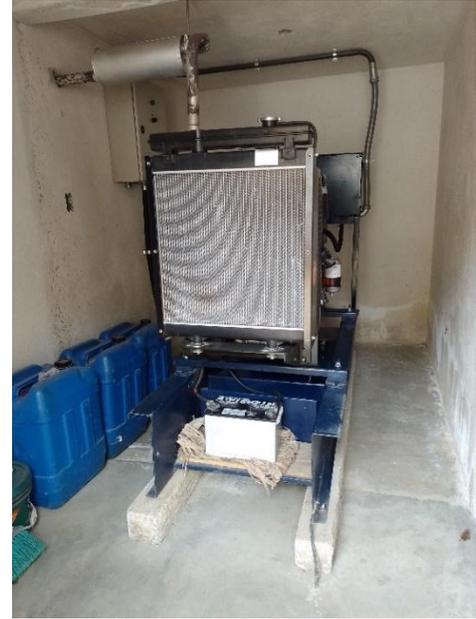
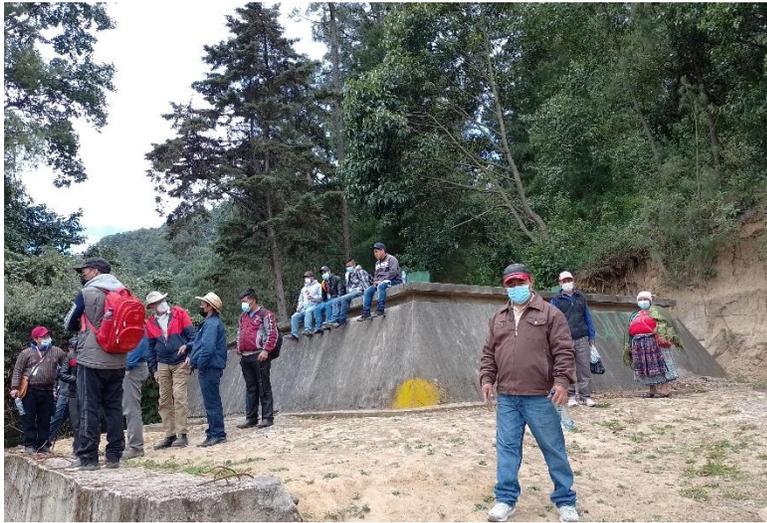
A robust distribution tank of good size was built in one of the highest points in the community. It is a semi-buried tank with stone masonry walls and reinforced concrete slabs. Its internal dimensions are 6.0 x 8.0 x 1.9 m, with a total volume of 91.20 m³.

Inside of pumphouse

Distribution tank, empty for now

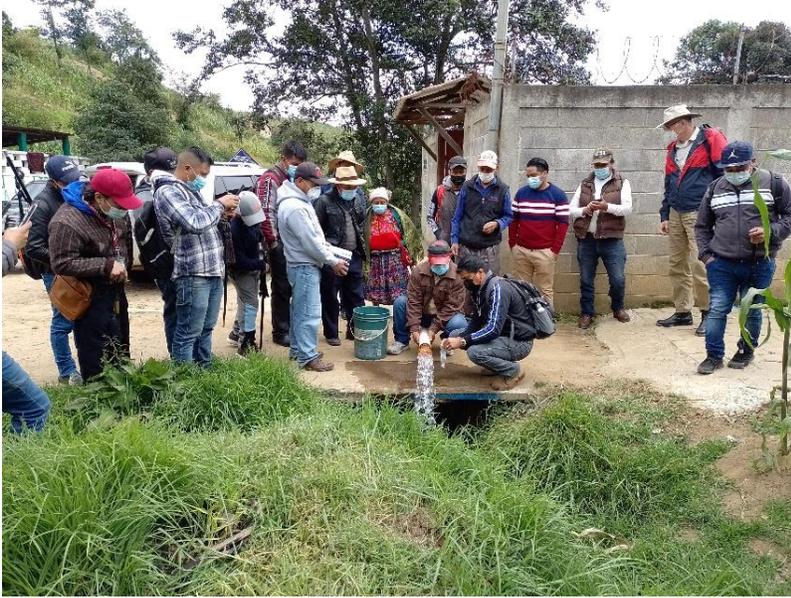
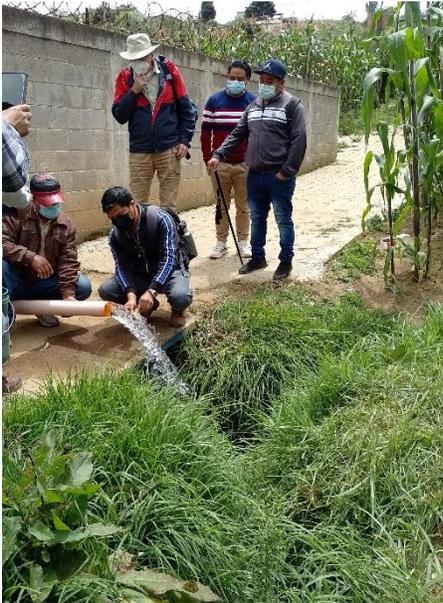
The flowrate was measured and water samples were taken. The flowrate was of 8.15 liters per second, and water quality tests show very good quality of water as shown in Appendix 1.

Well/pump flowrate measurement and water sampling

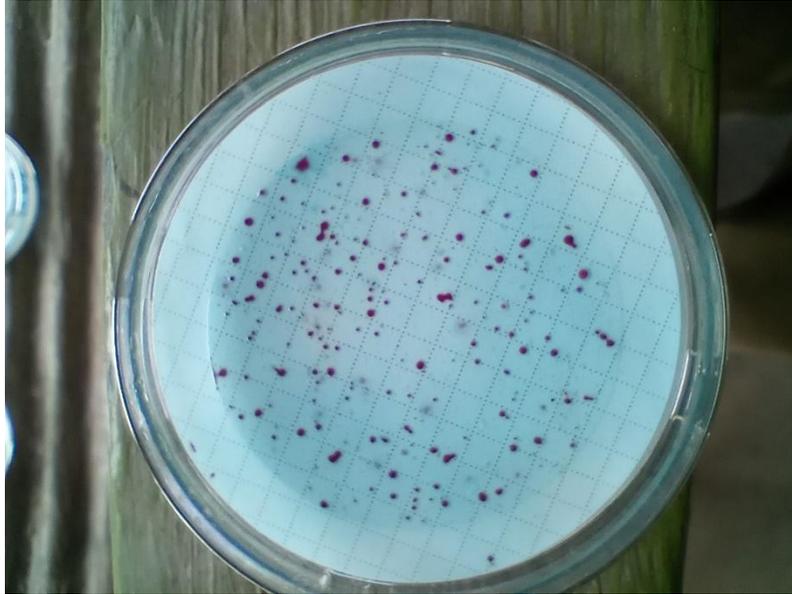
Bacteriological test, 3 Parajes Water System

Physicochemical parameters tested are within national quality standards.
Bacteriological test shows high presence of coliform bacteria.

The Guatemalan government requires specifically chlorination to be installed in all water systems. A tablet chlorinator is recommended.

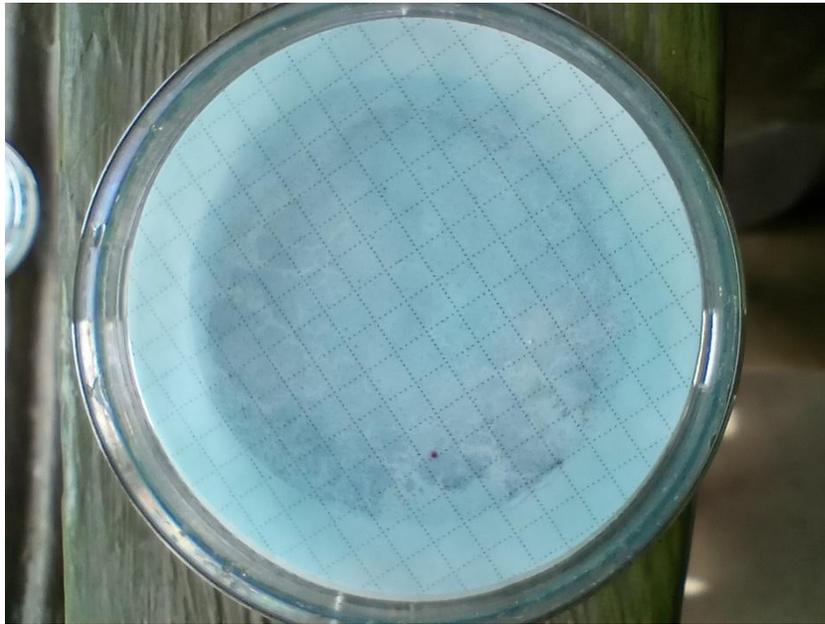
Bacteriological test, Drilled Well

Physicochemical parameters tested are all within national water quality standards. Bacteriological test shows water cleanliness, as expected from a well source.
