Wyoming Veterans Memorial Museum

1942 Chevrolet Fire Truck Update

Week Ending 4/4/2020

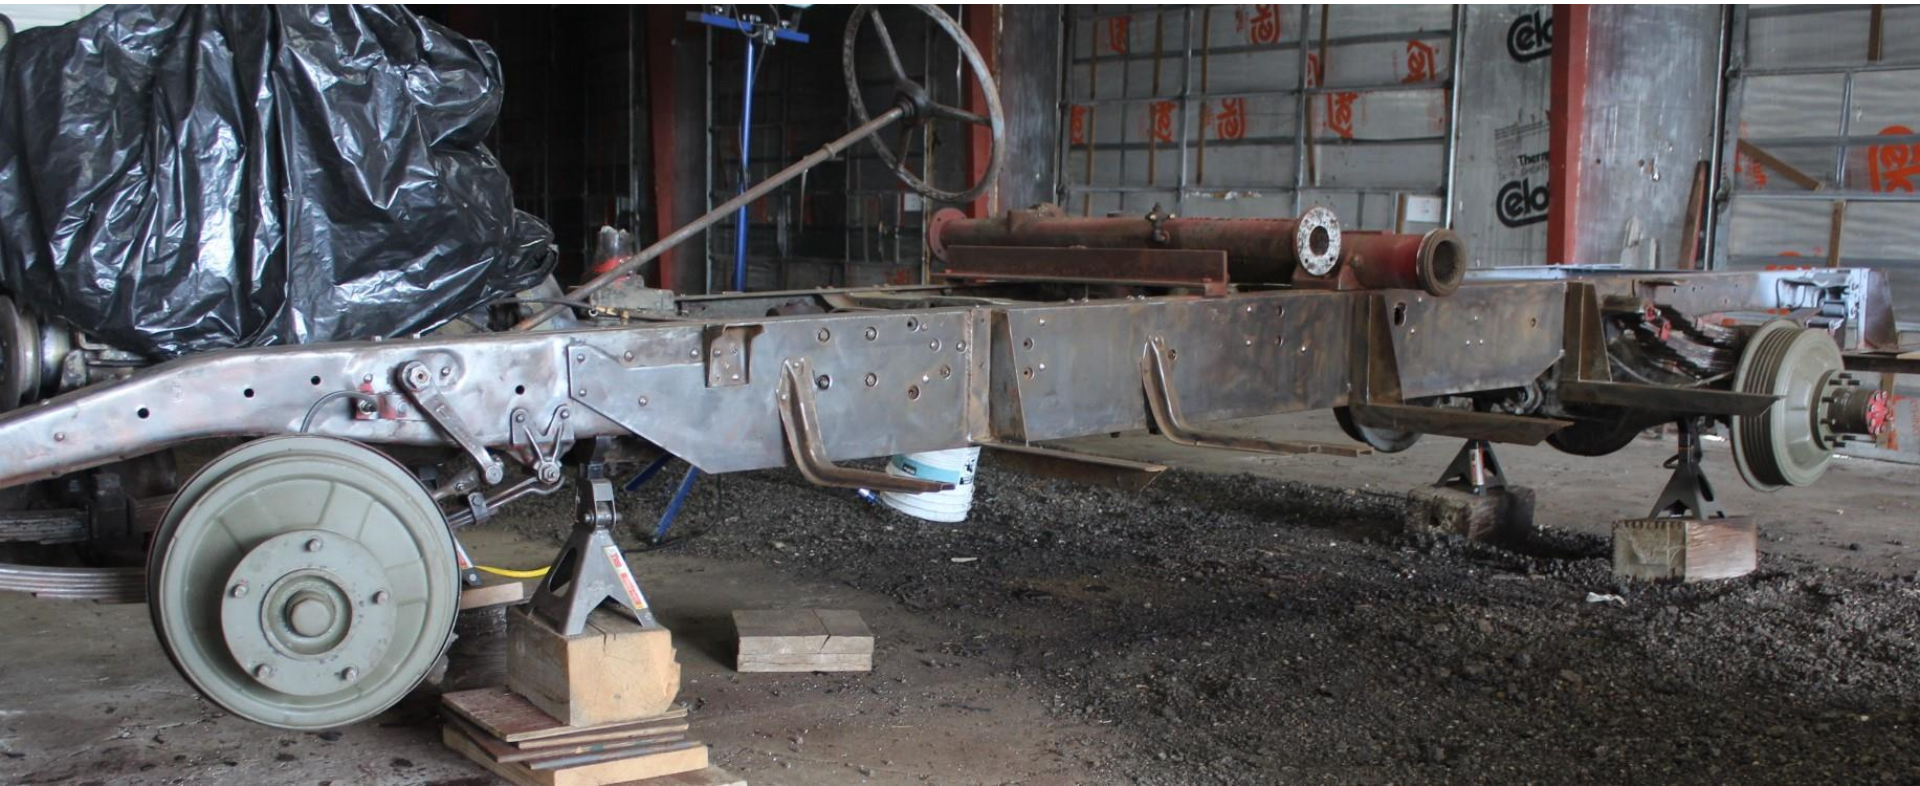
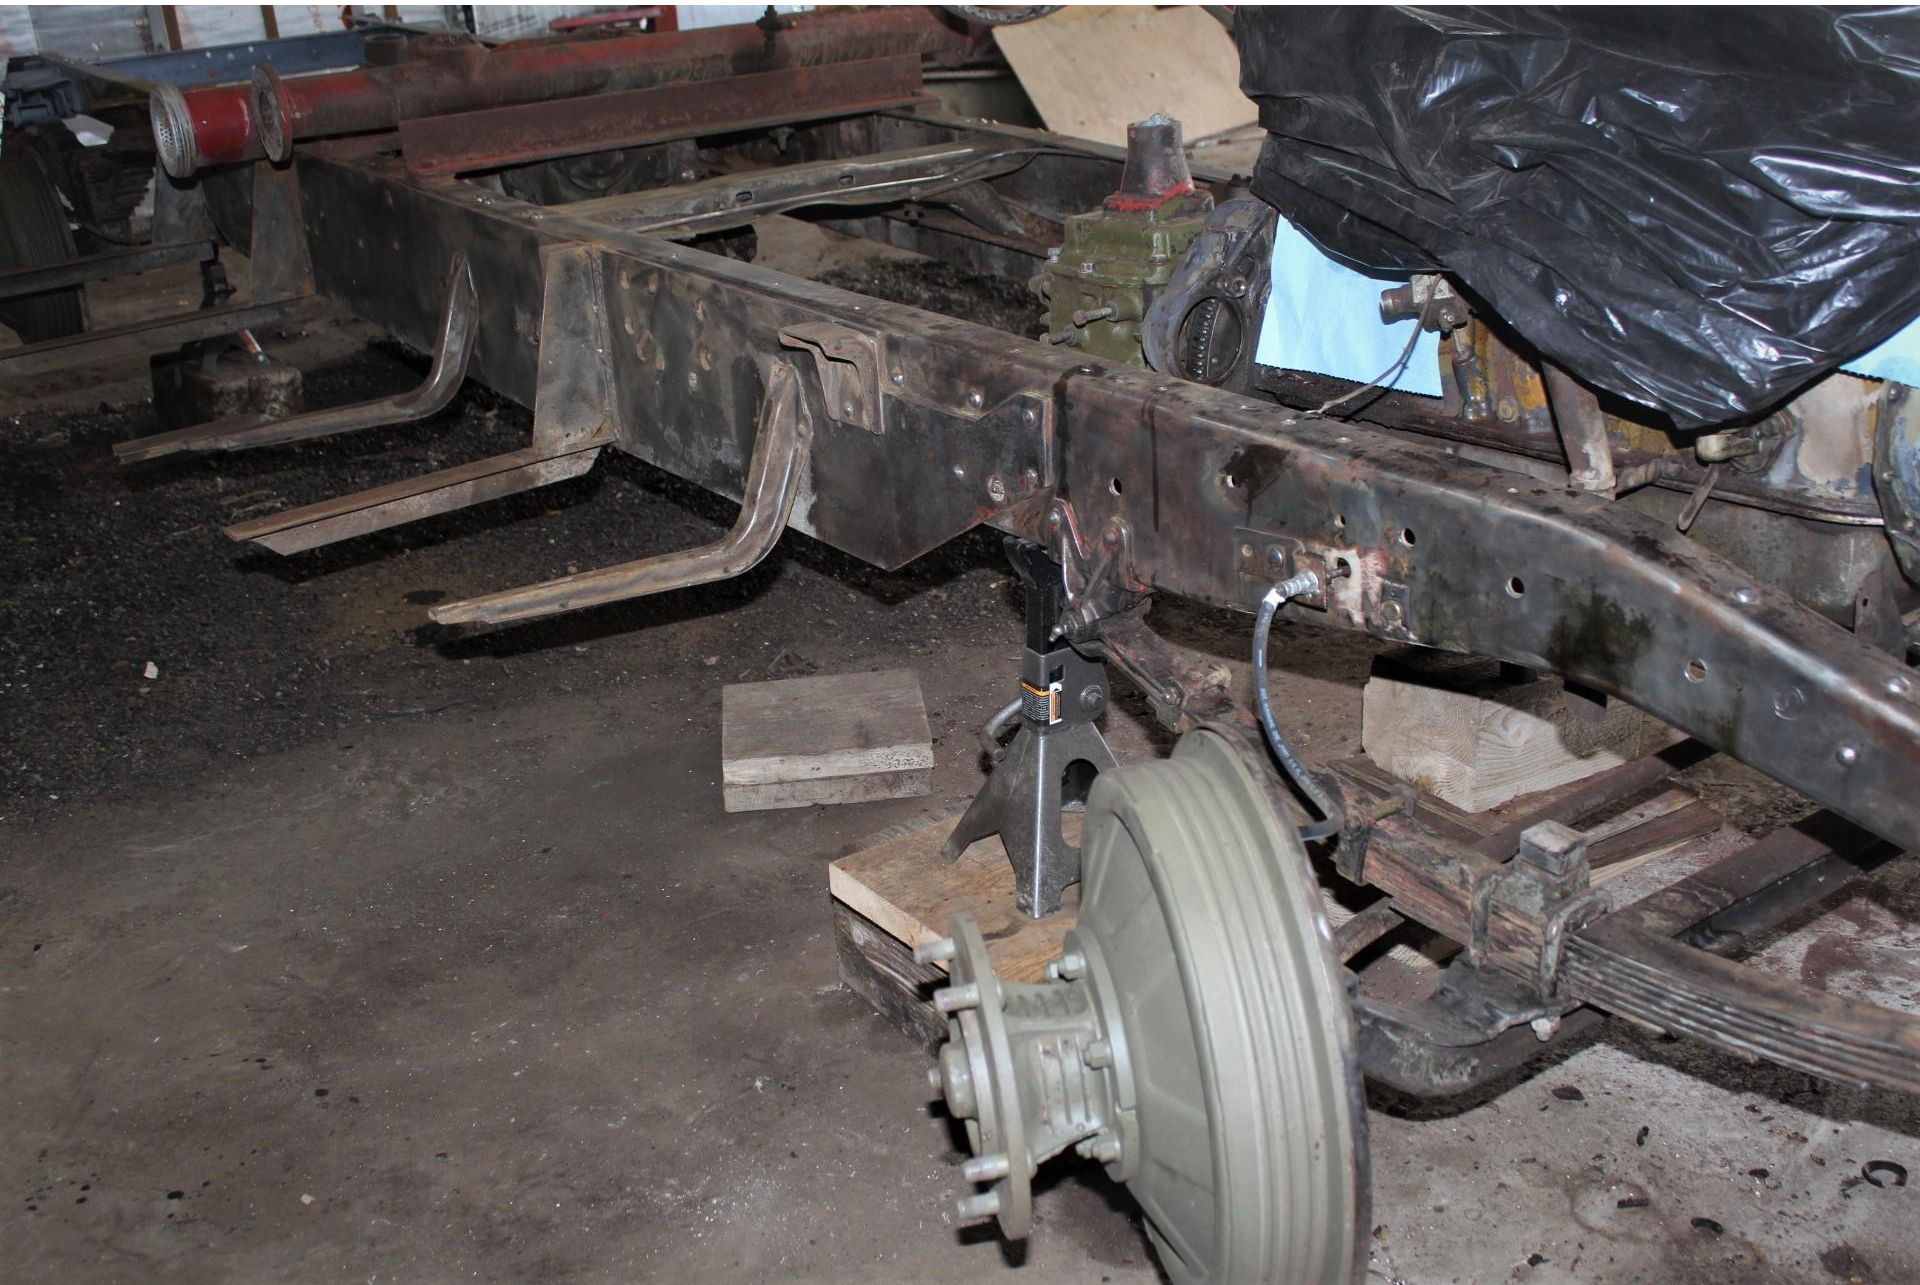
Much paint and corrosion has been removed from the exterior parts of the frame by wire brushing. The corrosion is so extensive that not all can be removed, except perhaps by sandblasting. That's not being planned at this time.

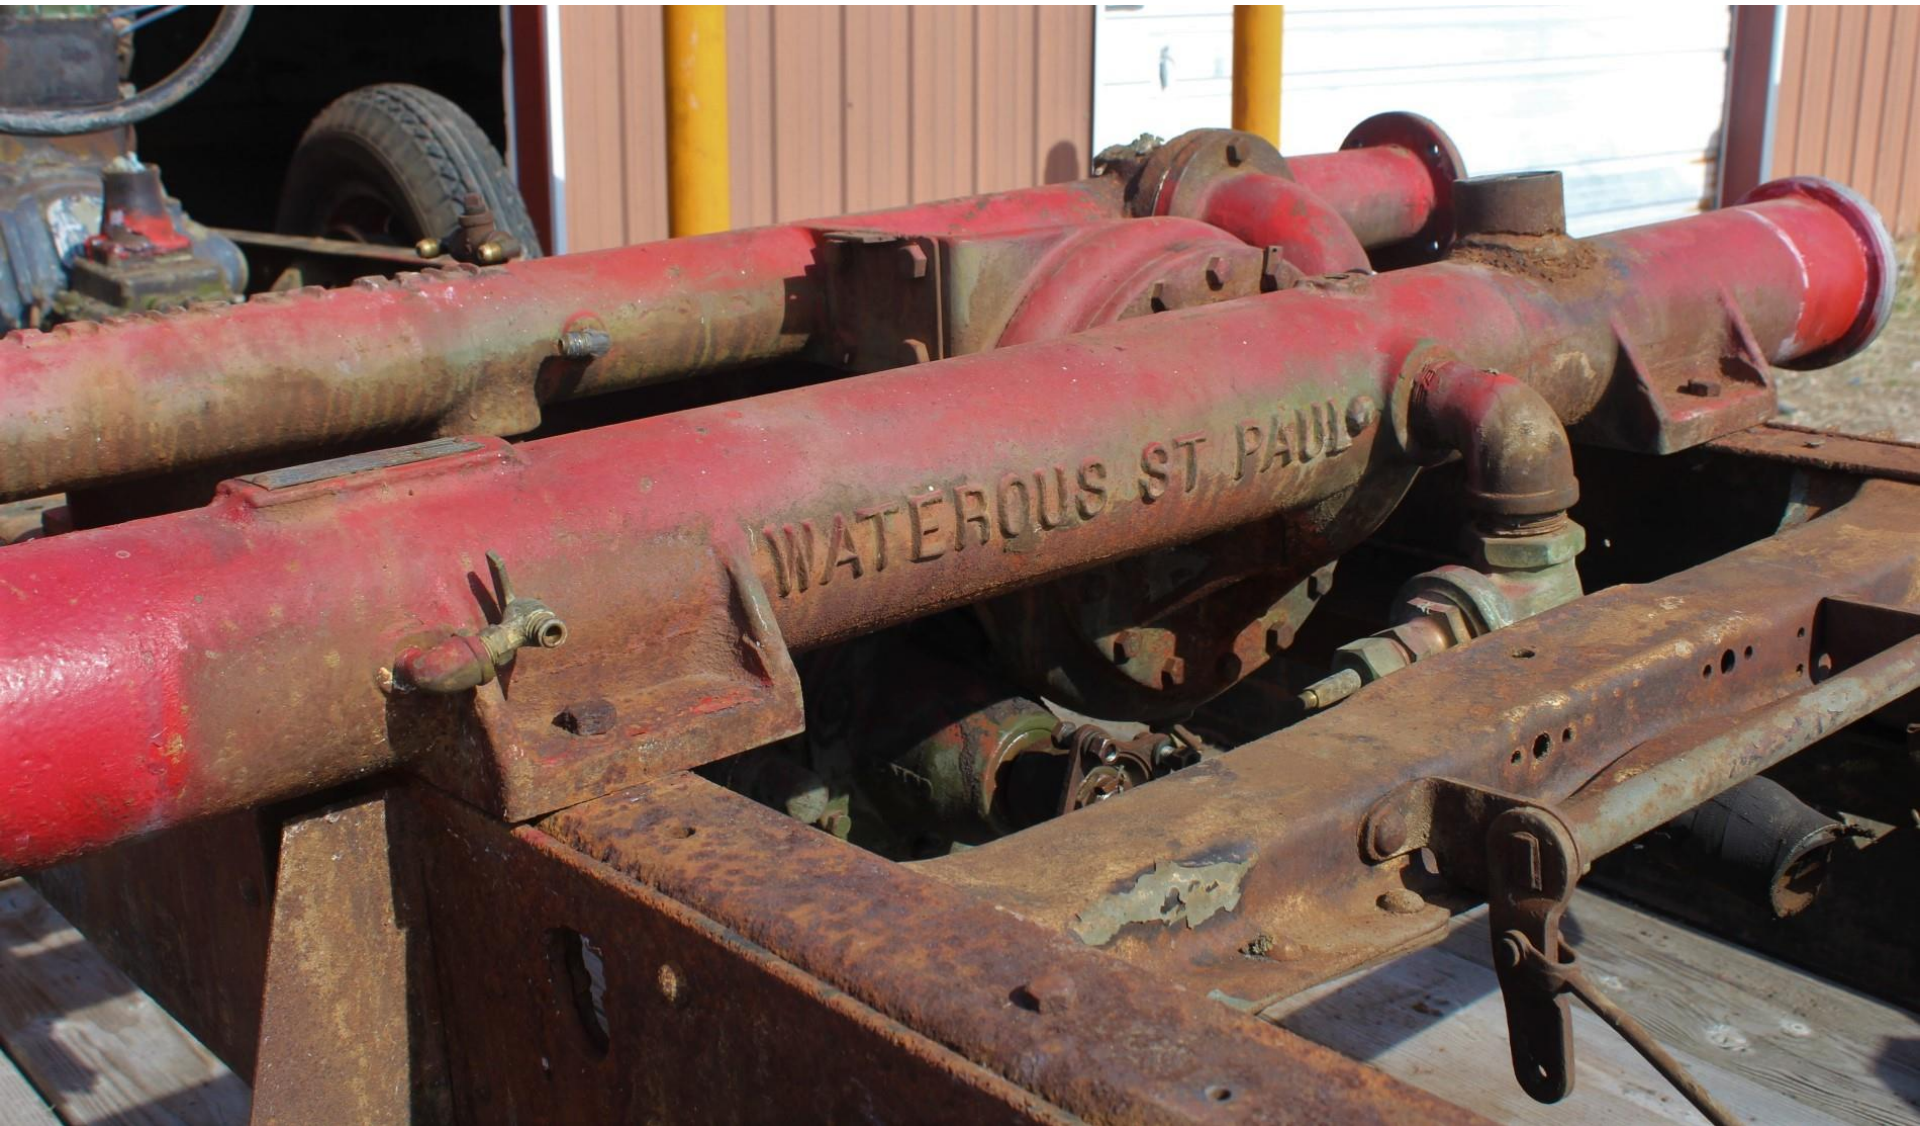
The centrifugal pump and transfer case assembly. An option suggested by Dana Jones is to replace this unit with a standard cross member and support bearing, with two longer drive shafts. He may have all of the materials needed for the conversion.
