THE PROJECT COORDINATOR
NKONDO SUB COUNTY VALLEY DAM PROJECT
ROTARY CLUB OF NORTH KAMPALA

PROGRESS ON NKONDO SUB COUNTY VALLEY DAM EXCAVATION.

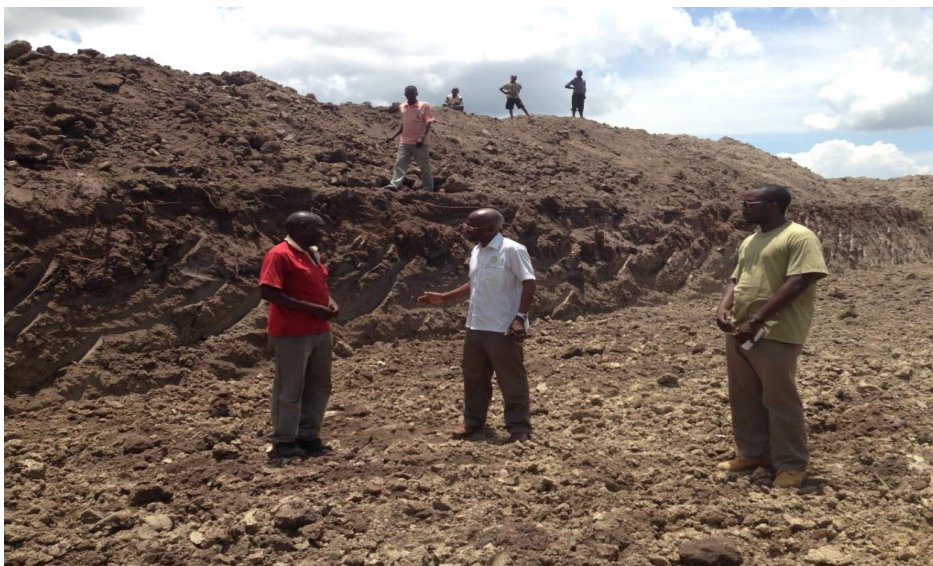
Site visit on 05/April/2014 between Eng Batumbya and WGUL field staff.

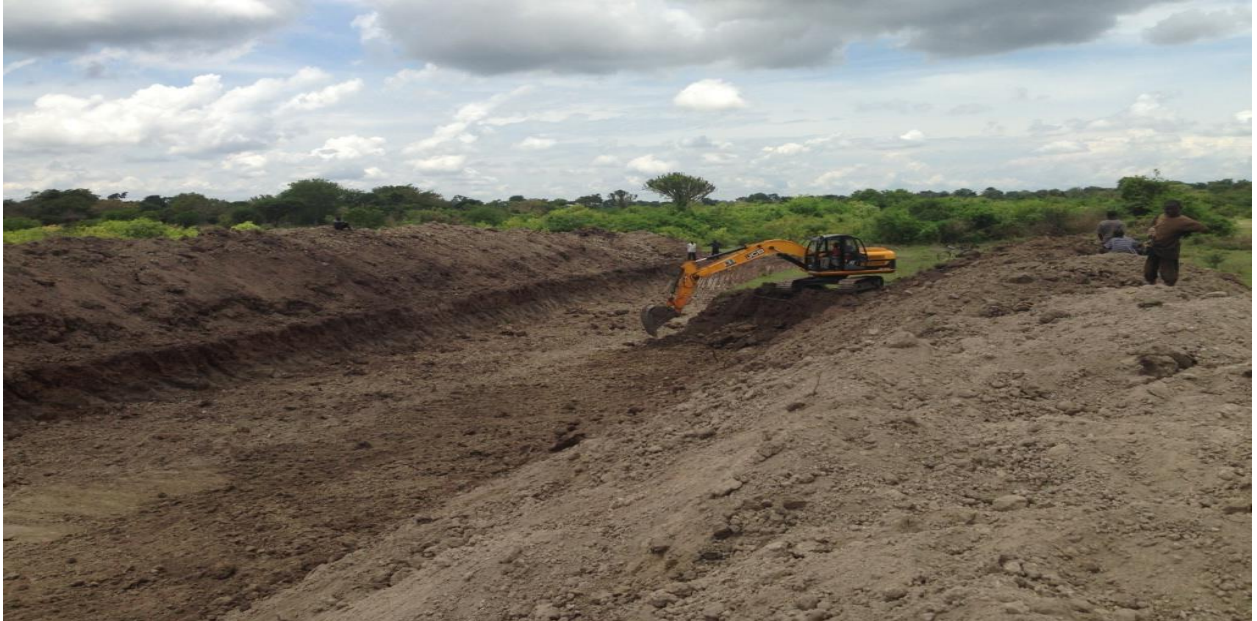
W8 working on Bulagala site(Kabazala) 05/April/2014 W8 worked at this site starting on 27/April/2014 and worked 18 days here.

The machine was delivered by lowbed to the dam site on 26/March/2014 and started work on 27/March/2014. It made steady progress and was inspected by Eng Batumbya and the Contractor's team on 05/April/2014. After advising on the progress to date, the operator was given the final directives on how to finish the site. The machine finished all works on this dam on 17/April/2014 and was moved on to Nseka Seka dam to help W9 finish that dam.

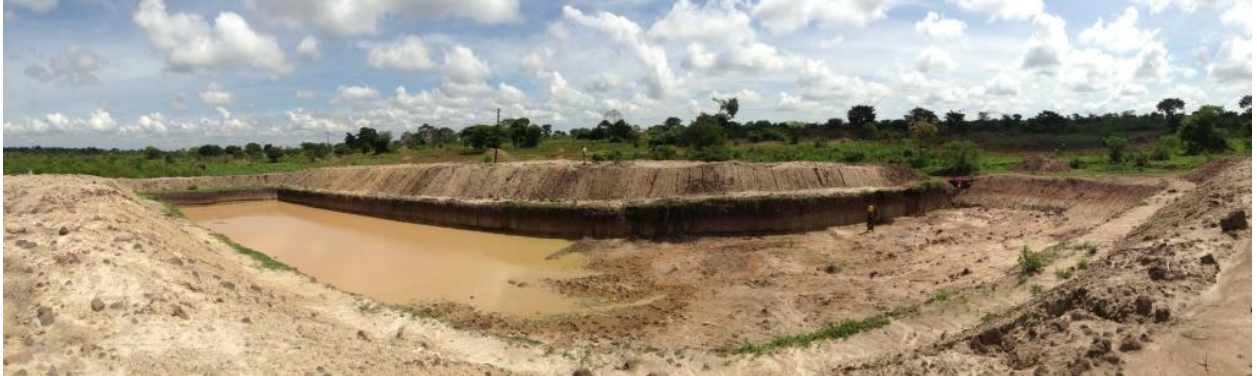
Panoramic view of Kigeizere Valley tank

When the work at this site is done, The Contractor shall transport the machines to the first site Kigeizere to do the finishing works (ie sloping the banks and working on the channels).

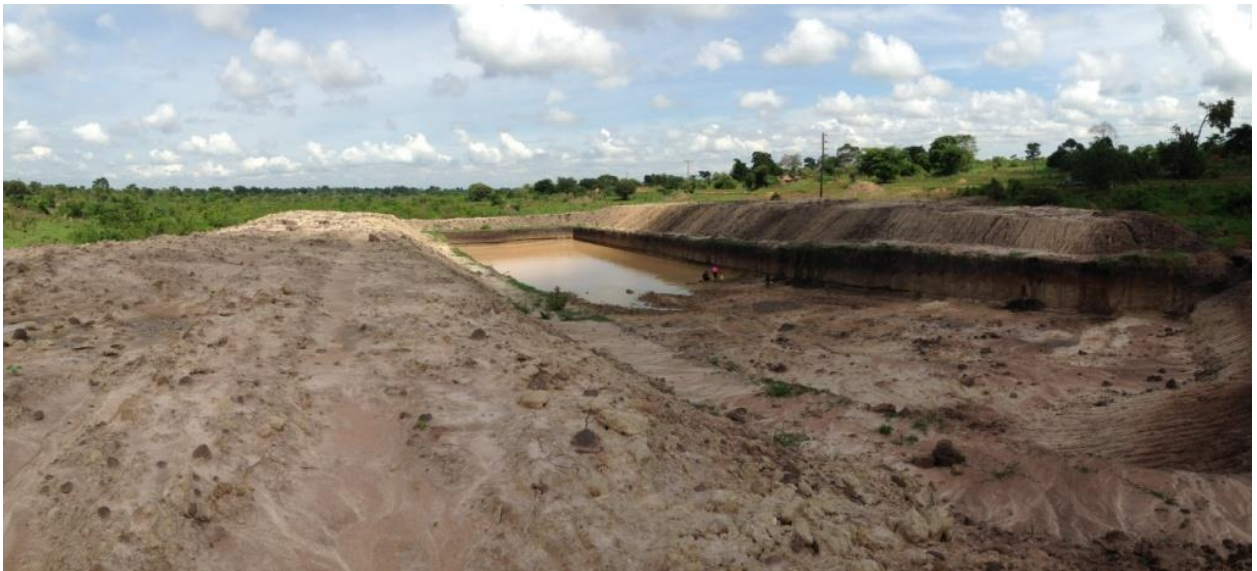
View of Kigeizere Valley tank showing need for final works.
