**PPP TEAM WATER & SANITATION  
NEEDS ASSESSMENT**

**BUGIRI DISTRICT, UGANDA  
PROJECT NO. 30001  
29 May 2013**

**PREPARED FOR:  
The Rotary Foundation (TRF) &  
The Water & Sanitation Rotarian  
Action Group (WASRAG)**

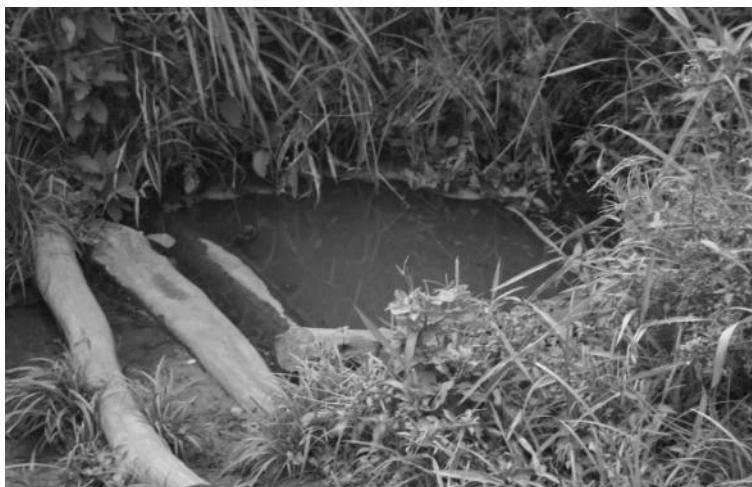
Figure 3.1 Unprotected Spring

Figure 3.1 shows a typical example of such a source. The proximity of these sources or the congestion found at the improved sources typically drives people to utilize these contaminated waters for domestic purposes.

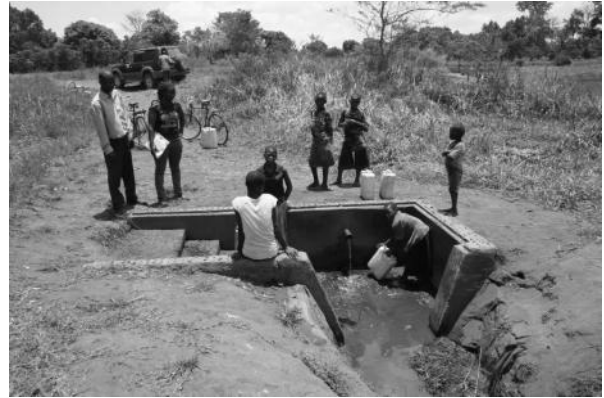
Figure 3.2 Protected Spring

Developing a protected spring in the project area typically consists of excavating an area where water consistently reaches the surface. A concrete wall and pad are constructed with gravel filling a large area on the upgradient side of the wall to provide a subsurface reservoir for the water. The gravel is capped over with a clayey soil to limit infiltration from the surface. A discharge pipe or pipes protrude through the wall to provide for filling the collection vessels on the downstream side and have a perforated end that extends into the gravel on the upstream side. An example of a protected spring is found in Figure 3.2.

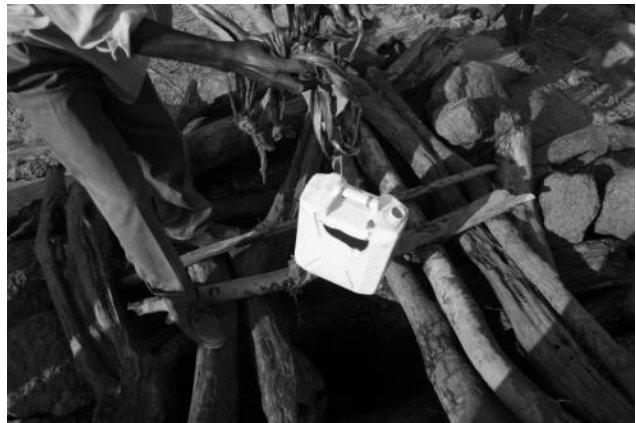
Figure 3.3 Unlined Well

Like springs, wells can be found as merely hand dug pits excavated to reach the water table or as a lined well. The former is invariably contaminated. While the lined well has some modicum of protection by the well lining and extension of that protection above ground level to prevent the entry of runoff, these wells are typically contaminated above government accepted levels. Dust and debris can readily enter the well at the surface and fact that the vessel used to draw the water is handled and often set down on the pad adjacent to the well there is ample opportunity for contaminants to come in contact with the drinking water.

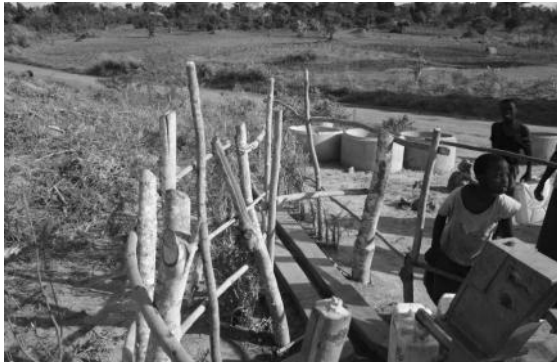
Figure 3.4 Lined Well With Handpump

on a borehole, i.e. concrete pedestal, pad, and drainage trough with a Mark III handpump installed.

While this greatly improves the water quality, as compared to shallow wells that are open at the surface, shallow groundwater is typically more vulnerable to contamination than the deeper aquifers.

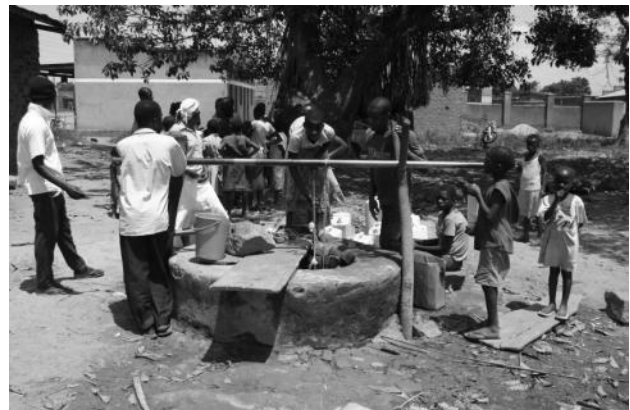
Figure 3.5 Open Lined Well With Windlass

As an incremental improvement in source protection some shallow wells have been retrofitted to better prevent the entry of contaminants. In essence the well is relined with reinforced concrete pipe (RCP) and the surface is developed in a manner that is identical to the wellhead protection

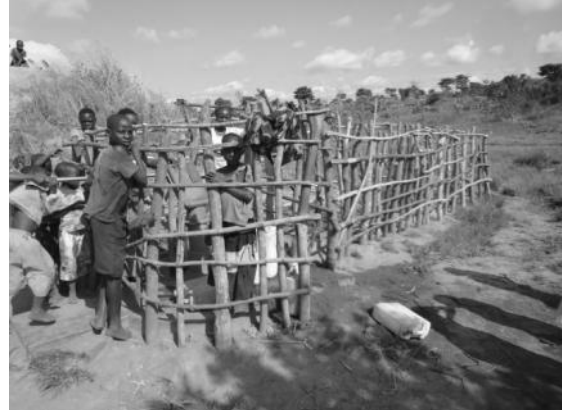
Figure 3.6 Borehole With Fence

In most cases the only protection afforded the borehole is in the proximity restrictions to potential pollutant sources. In some cases the wellhead may also be enclosed by a wooden fence to stave off damage by livestock which is typically unrestrained. Examples of a typical borehole and one protected by a fence are shown in Figures 3.6 and 3.7.

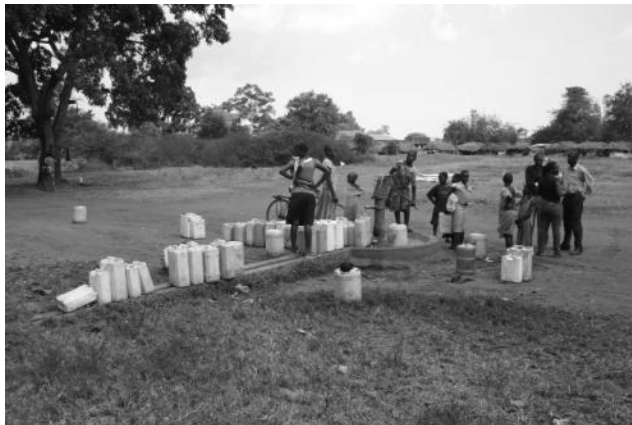
Figure 3.7 Typical Borehole

On the surface a pump pedestal and pad of concrete is constructed, along with a trough to drain excess water away from the pump column. The most prevalent pump used is the Mark III and sources for the pump and parts can be found in-country. A pump currently being introduced by UMURDA is the Canzee pump; however,

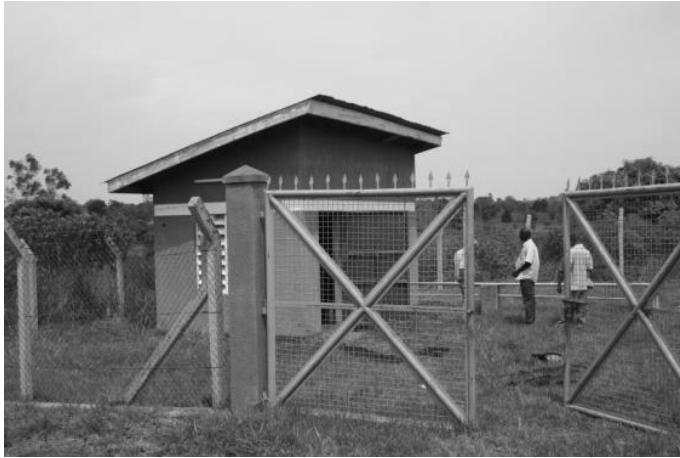
Figure 3.9 Nankoma Village Borehole

Two piped systems were observed in the subject sub-counties; one in the village of Nankoma in Nankoma Sub-County and the other in Wakawaka in Bulidha Sub-County. In Nankoma village, the water source is a 52 m borehole with a GRUNDFOS SP8A-37 pump that is powered by a diesel generator. The water is pumped to the system and

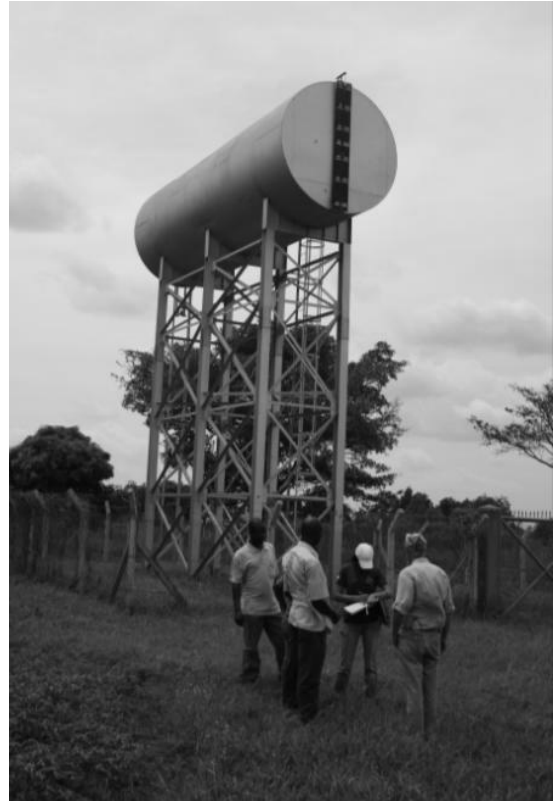
Figure 3.8 Nankoma Village Water Tank

a 60,000L tank daily. Water is distributed to consumers via 67 house connections, two kiosks with enclosed vendor booths, and ten standpipes. All delivery points are metered and water is sold for UGX 100/jerry can to fund system O&M. There is no disinfection provided.

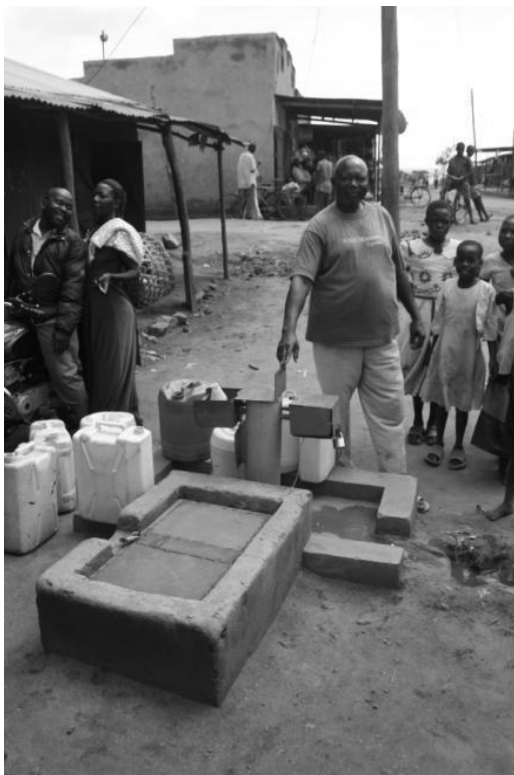
Figure 3.10 Wakawaka Standpipe

As with the Nankoma system, the water is not disinfected; however, since it is lake water it is more likely to fail government water quality standards.

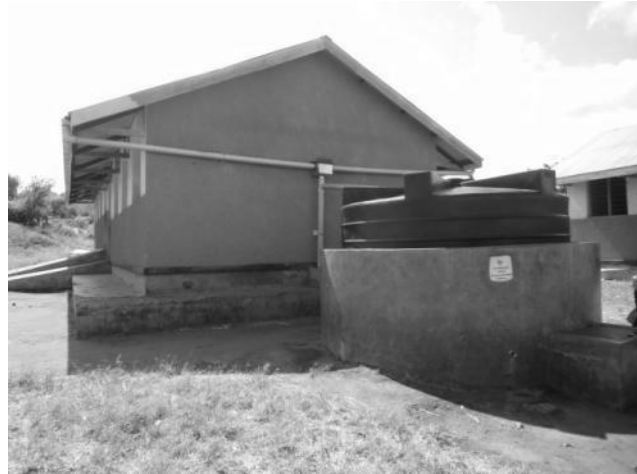
Figure 3.11 Rainwater Catchment - Plastic

Rainwater catchment tanks are predominantly found at the public schools and regional Health Centres. These consisted of both plastic or ferrocement tanks

with a small portion of the available roof area guttered. Many of the systems observed were non-functional; often as a result of needed gutter repairs, but nearly as frequently as a result of damage to the plastic tanks. It was reported that some of the schools where the neighboring households were denied access the tank damage was a result of vandalism.

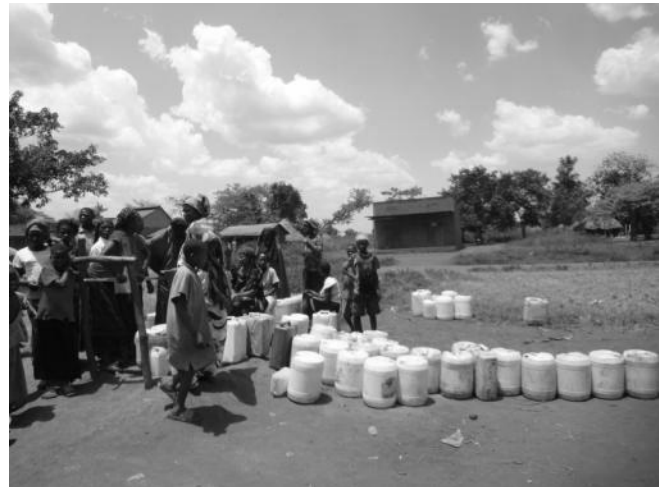
Figure 3.13 Congestion at Boreholes

**Time of Year** – As previously discussed, there are two dry seasons in Bugiri District. The assessment trip was conducted in March, the end of the winter dry season. Several water sources were heavily stressed by usage and the water source was dry or had low yields. Most boreholes remained viable throughout the dry season; however, some were impacted by assumedly a low water table.

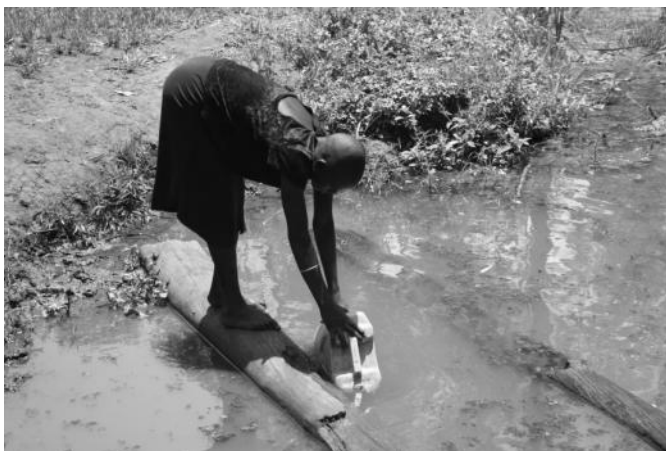
Figure 3.14 Contaminated Drinking Water Source

Surface water is predominantly found in wetlands and marshes. Springs may be intercepted and developed and, if the watershed can be protected, may yield potable water that meets WHO limits. In the south plans are available for drawing water from Lake Victoria; which includes treatment works to bring the water up to acceptable standards. A large number of households rely on surface water sources or shallow wells dug out in the nearby swamps. This water invariably has coliforms counts of “too numerous to count” (TNTC). Also see Figure 3.14.

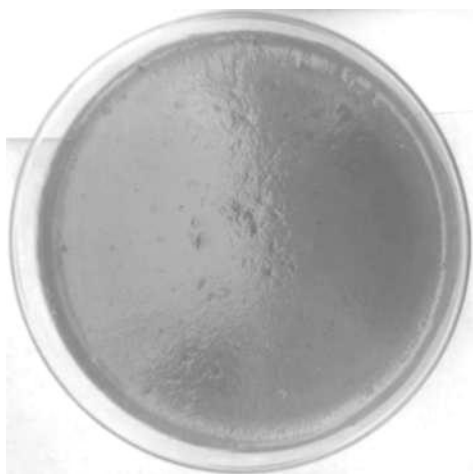
Exhibit 3.1 E.Coli Sample with No Colonies

Water quality testing was conducted at several of the water points to gather information on total Coliforms and Escherichia coli (*e. coli*), iron, hardness, pH, chlorine, and temperature. For each water source, a 10ml sample was collected and poured directly into a container of Easy Gel Coliscan Medium. This test samples 1-5ml and is ideal for testing in the field since the sample can be held under warm conditions (32-37°C) and incubation temperature is not critical. Each bottle was labeled with the GPS coordinates collected by the handheld units and recorded in the survey forms. The plates were stored at 37°C for 24 hours prior to conducting a coliforms count.

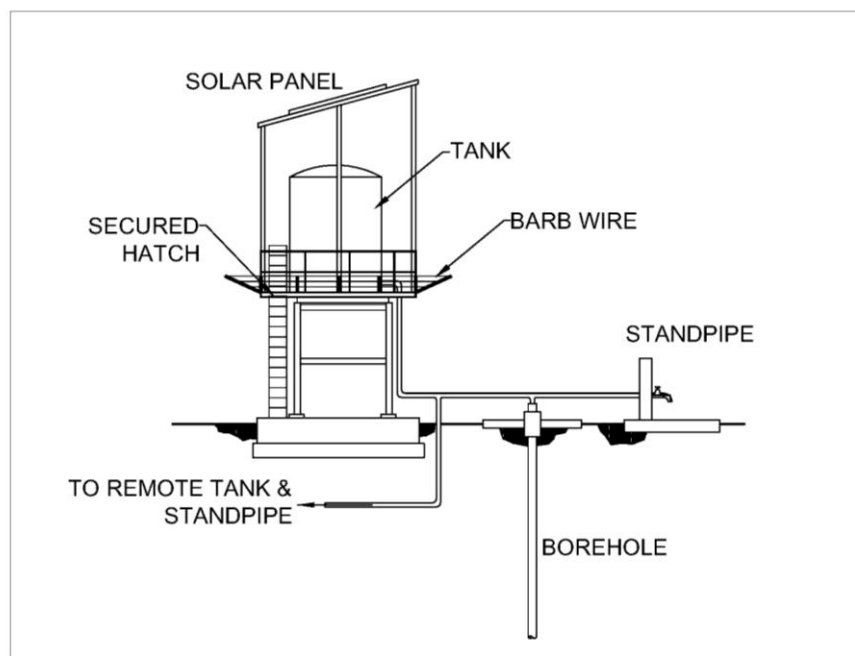
Exhibit 3.4 Government Conceptual Design

The conceptual design proposed here is in between. Whereas it does not include the fence and lights proposed by ADB it does include the installation of barbed wire on the tank/panel tower and access for O&M is through a locked hatch. Note that any deterrents can be readily circumvented by a determined thief. The construction of solar boreholes should only be implemented in the vicinity of housing clusters where multiple villagers may be able to respond if the alarm is tripped. To cover the costs of additional security features a 10 percent factor is being added to the JICA version of the solar borehole system.

The conceptual opinion of probable construction costs, including a second elevated tank and standpipe located 2km from the borehole, is expected to be around UGX 77 million (USD 29,700).

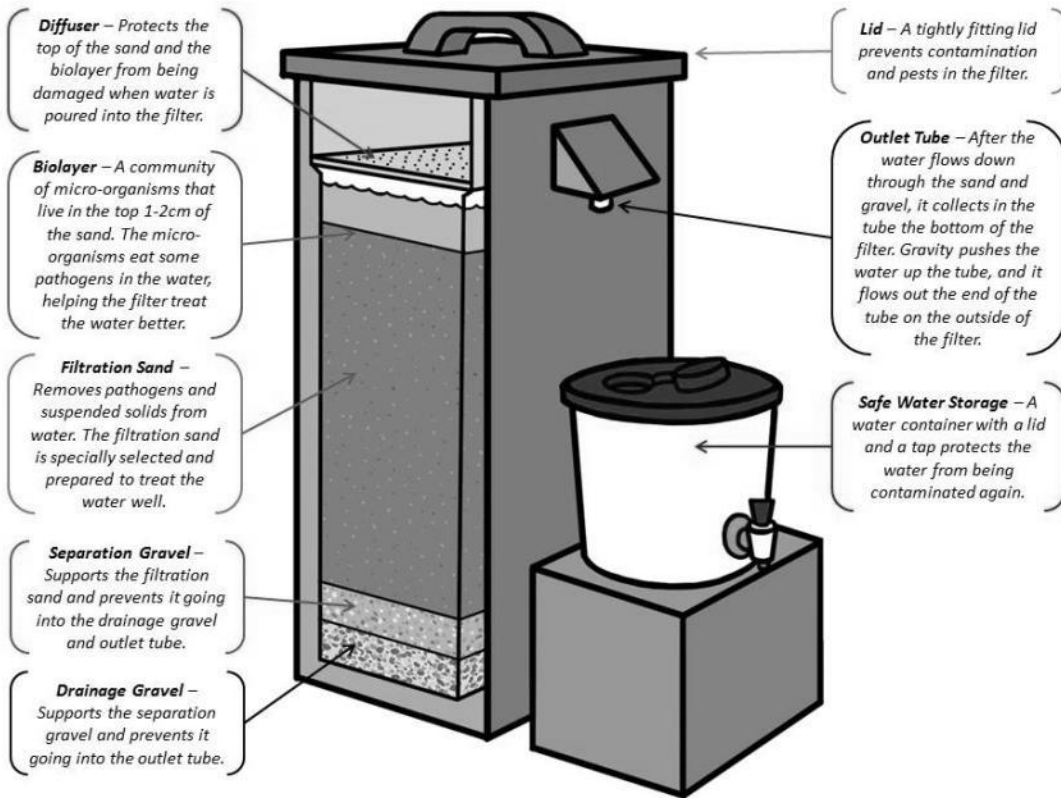
Exhibit 3.5 Biosand Filter  
Source: CAWST website, 2013

Based on laboratory and field study, BSF have been shown to remove the following:

- Up to 100 percent of helminthes (worms)
- Up to 100 percent of protozoa
- Up to 98.5 percent of bacteria
- 70-99 percent of viruses

Based on a 2010 project in Kenya, the cost per unit for a plastic BFS is around UGX 26,000 (USD 10) including delivery and installation. At an assumed treatment rate of 15L/hr an average household of six persons can treat enough water for the family each day with one unit.

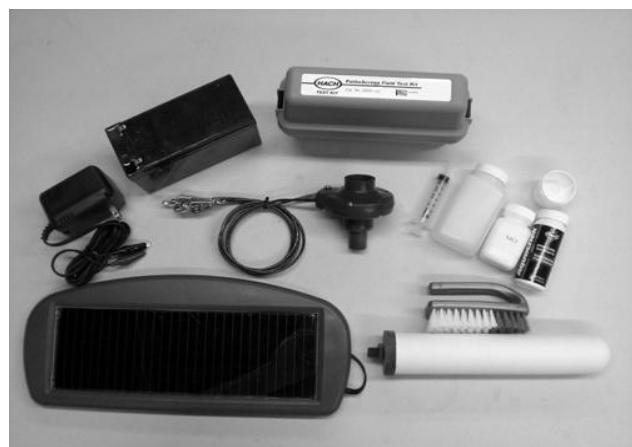
Figure 3.15 Khlor Gen Chlorine Generator Kit

The Hays Pure Water For All Foundation has a similar device that can be obtained in a kit that includes a 6v battery and small solar panel to recharge it. This kit, called the Khlor Gen System sells for UGX 1.5 million (USD 567).

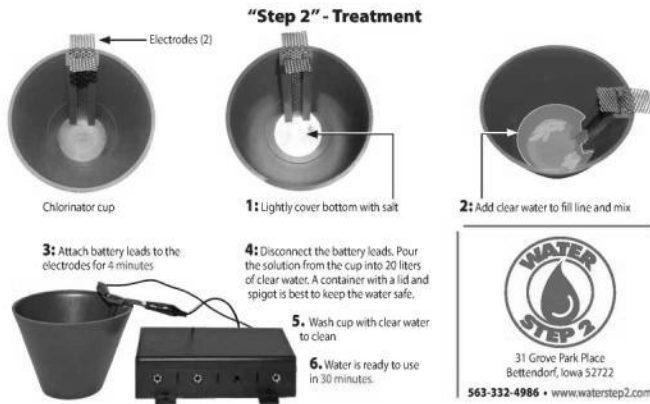
Figure 3.16 Step @ Chlorine Generator Kit

For the household or family compound level it may be possible to use a small chlorine generator developed by the University of Iowa referred to as the “Step 2”. This unit operates on D-size batteries or other sources of approximately 6v DC. A kit is available from Water Step 2, including the first set of batteries and a battery holder, for USD 20 plus shipping. Recently an upgraded version became available that has a circuit board that will turn the unit off after a set period of time and allows you to leave the batteries in the holder. This upgraded unit sells for UGX 78,000 (USD 30).

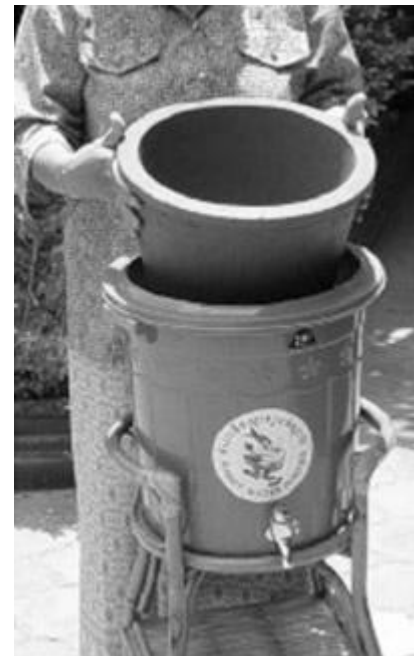
Figure 3.17 Ceramic Pot

These devices are essentially filters with extremely small pore sizes. The pots can be set on top of the storage vessel or mounted above it. The user fills the pot with contaminated water and it is allowed to drip through over the course of the day. The candle is a small tubular device. The candle can be mounted inside of a vessel and operated in a similar manner as the ceramic pot with the water dripping through to a storage vessel or it can be used like a straw and water drawn through the device under a vacuum.

It may be possible to create a business to manufacture ceramic pots in Bugiri or one of the other more urban centers. If produced locally, the filter cost may be available in the UGX 20,000 ~ 80,000 range (USD 7.50 ~ 30.00). However, a single pot capacity is only 20L/d, so one unit may be required for each family member. There is also an increased likelihood that untreated water will be used for drinking since the filtered water may not be available on demand.

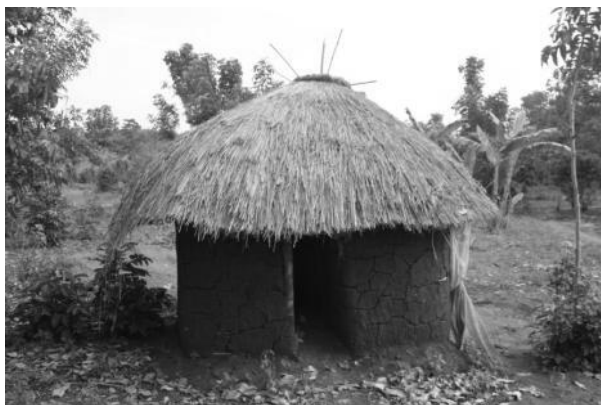
Figure 4.1 Traditional Pit Privy

Of the pit latrines, field observation indicates these are nearly universally of the traditional pit privy (TPP) type with an earthen floor over a wooden support structure. The condition of the

enclosure varies significantly from one community to another. Typically, the walls are constructed of a plastered mud brick and the roof, if present, is thatched material. The use of a concrete squat plate to transform the TPP to an improved pit privy (IPP) was not

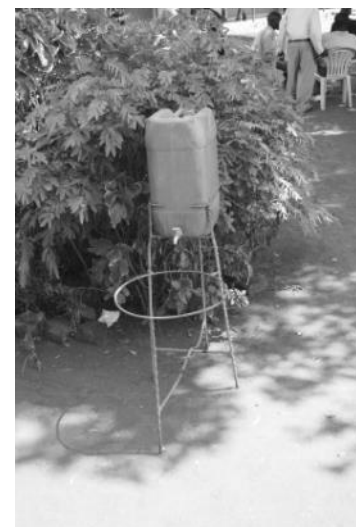
Figure 4.5 Hand Washing Station

In the schools the availability of a handwashing stand is widespread. One school actually had a small catchment collecting rainwater from the latrine roof and a hose bibb

piped into one of the girl's stalls to provide a means for menstruating girls to maintain cleanliness. However, almost all of the handwashing stations were dry. The distance to a water source precludes the ability of the schools to keep the stations full except during the rainy season when the available rainwater catchment tanks serve as the source.

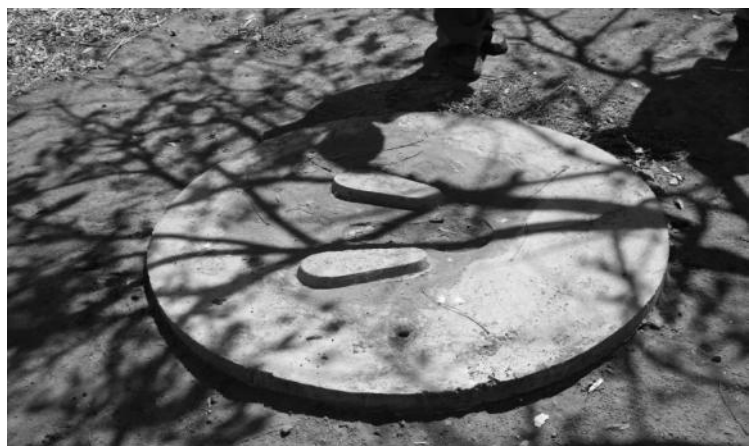
Figure 4.6 Concrete Squat Plate

This report only considers the concrete squat plate, with respect to IPPs. This will entail retrofitting the TPPs that are commonly found in the area. The concept here would be to create local startup businesses to manufacture the units. The cost per plate is anticipated to be in the neighborhood of UGX 65,000 (USD 25).

A concrete squat plate improves sanitation by providing a surface that can be more readily cleaned. It also improves safety in that traditional earth covered timber supports are vulnerable to attack by termites. The retrofitting of TPPs with concrete squat plates would be considered an incremental step in sanitation improvement with an eventual move toward a VIP or composting toilet.
